# Dowel Bar Retrofit

## TECH BRIEF

*This document is a brief technical summary of the MoDOT case study **Dowel Bar Retrofit Case Study for Washington and Other Leading States** which is included in a larger report, **Concrete Repair Best Practices: A Series of Case Studies**, Publication no. cmr 17-013, November 2017.*

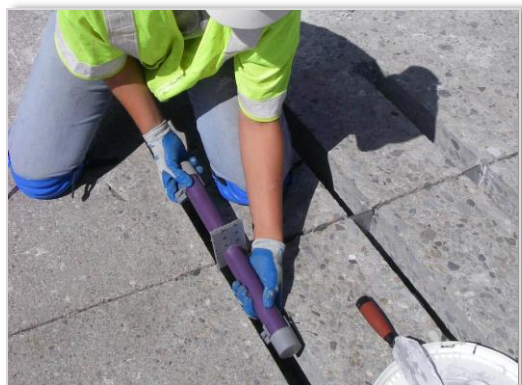
**Dowel Bar Assembly.** The lubricated dowel bar assembly is placed into the slot, as shown in Figure 2. The dowel is lightly coated with a parting compound, foam core board is placed on the dowel to establish the existing concrete joint, and end caps/chairs are placed on the ends of the dowels that will provide a minimum of ½-inch clearance from the bottom of the slot. The assembly is placed in the center of the slot. Other States use a similar approach.

Figure 2. Inserting dowel bar assembly into slot (Photo courtesy of Jeff Uhlmeier, Washington State DOT).
